Qualitative Evaluation of Reconstructed Masonry Residential Building after the Gorkha Earthquake 2015 in Rural Areas of Nepal: A Case Study at Bhalche, Nuwakot

Department of Civil Engineering, Pulchowk Campus, Institute of Engineering, Tribhuvan University

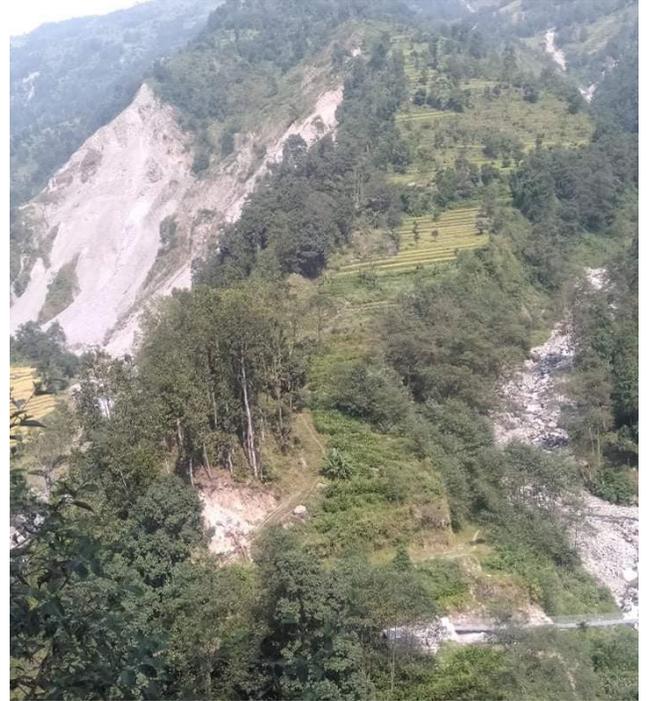
- i. **Site Selection:** 5 % of the reconstructed buildings were constructed on steep slopes with underlying soft soil deposits along with decayed rocks, so the areas are highly susceptible to landslides (Figure 6) during rainy seasons. It was found that an alternate land was provided to those fifteen house owners residing at that unsafe site for reconstruction, however, three of the house owners have not left the place yet due to poor economic backgrounds and unavailability of land and employment in alternate places for agricultural purposes.

Figure 6: Vulnerable Area

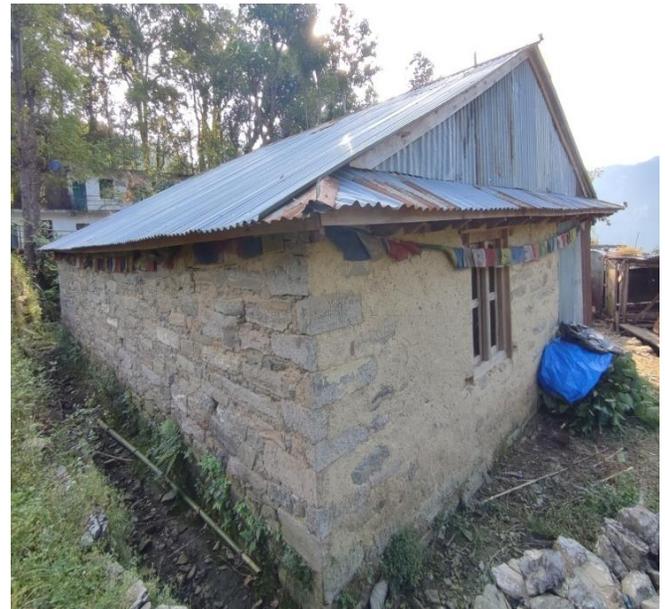
- v. **Horizontal band for integrity:** Use of intermediate bands –all of the houses constructed before the Grant and technical assistance from the Government of Nepal (GON), sill and lintel bands were placed in a haphazard manner (Figure 8) although, houses built with the grant and technical assistance from the GON has used in proper ways as in design catalog/Drawing (Figure 10) except a very few houses (3 out of 50) does not have bands as shown in Figure 7 and poor workmanship like the appearance of honeycombed in RCC band and lack of uniform thickness in wooden bands.

Figure 7: House with No horizontal band

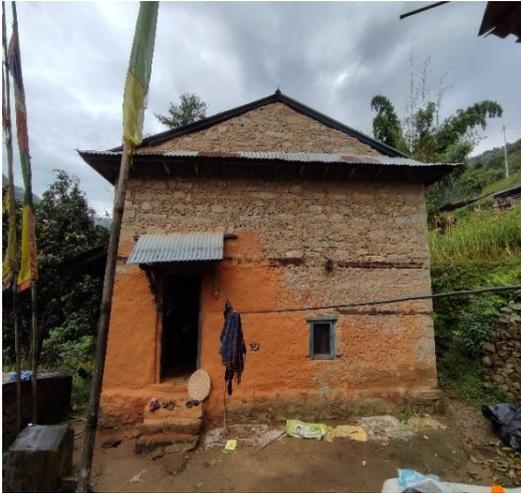
Figure 8: House with the haphazard location of bands

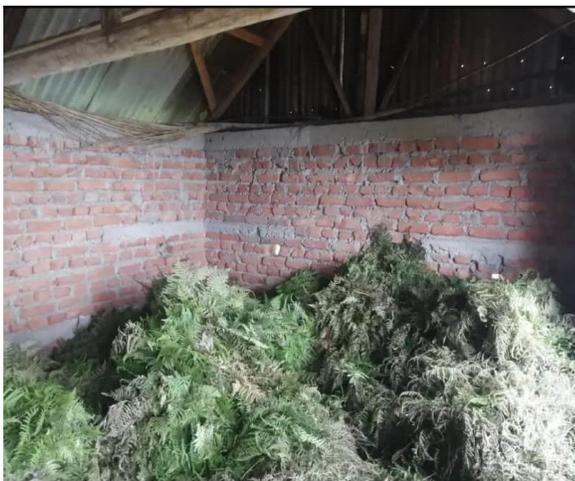
- ii. **Size of the room:** 95 % of buildings are one-room structures: Although these houses met the minimum carpet requirement stated by NRA, the 'functional' aspect is compromised. Most people have constructed an additional CGI shed on the side to accommodate the need for space.

Figure 9: House being used for storing cattle

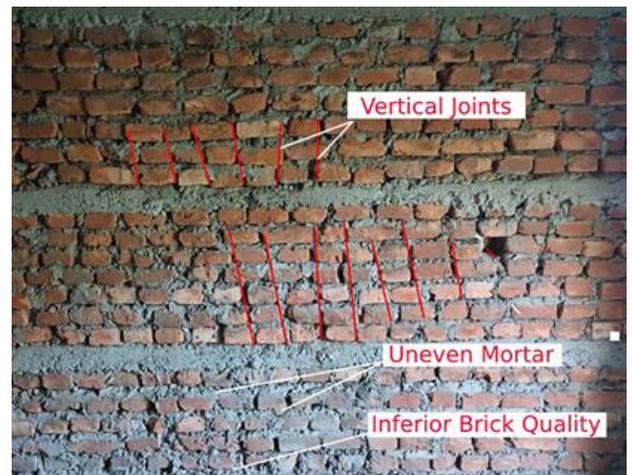
- iii. **Masonry Wall:** Vertical joints in the masonry wall (brick) are prominent in some buildings (Figure 11).
- iv. **Roof truss detailing:** In some of the buildings/houses (15%) Kingpost, Rafter and Purlin are deficient in numbers as shown in Figure 12 than in the drawing provided by NRA which may be the possible point for vulnerability resulting in a significant consequence by the hazard-like strong wind storm.

Figure 11: Vertical joint in brickwork

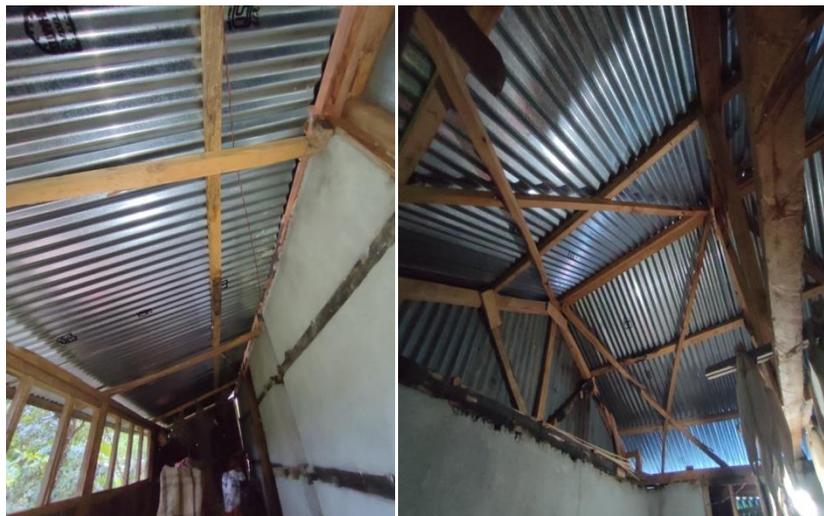
Figure 12: Inadequate rafter and Purlin in roof truss

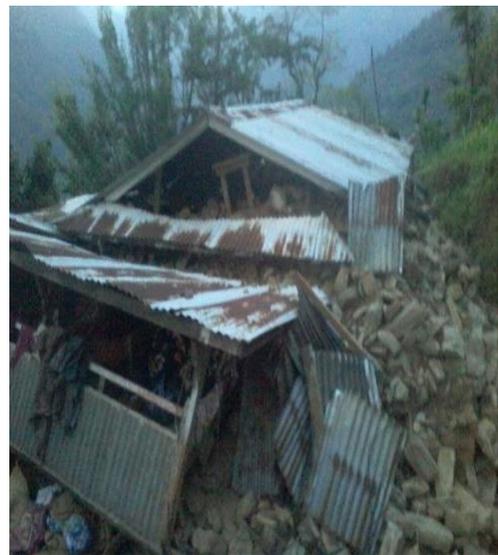
Figure 13: House destroyed By Gorkha earthquake

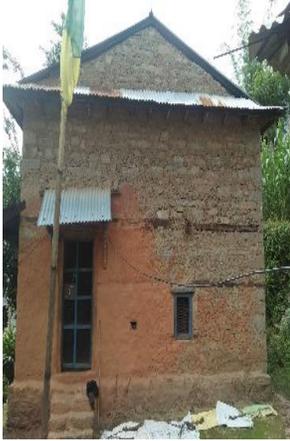
Maru Rani Tamang is a 65-year-old woman currently living in Bhalche, Kispang. She lives with a family of 5 members, with an overall monthly income of NRs 20,000. She is the interviewee for this particular case study. During the Gorkha earthquake, their three-storied building- made with stone masonry in mud mortar- collapsed (Figure 13). Consequently, her family lived in a temporary shed after the catastrophic event. Even after seven months after the event, due to the absence of aid from the government, they collected NRs 7, 00,000 from their relatives to construct a two-storied mud-mortar stone masonry building (Figure 14). Since they had started before

- No sill and lintel bands on the first floor.
- No intermediate, gable, or roof band provided.
- The placement of the window is random, without any consideration to the bands provided, etc.

Figure 14: House build without technical assistance
